## CHLORINE RESISTANCE TESTING OF PLASTIC PIPING MATERIALS

*P. Vibien, J. Couch and K. Oliphant, Jana Laboratories Inc., Aurora, ON  
W. Zhou, B. Zhang and A. Chudnovsky, University of Illinois at Chicago, Chicago, IL,  
USA, 60607*

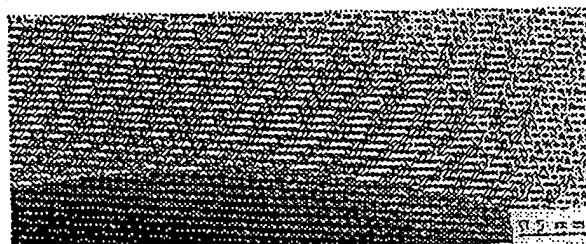
**2.A: 10% of Pipe Lifetime**

Figure 1 shows the inner exposed surface of the PEX piping material as a function of exposure time. Figure 2 shows the same samples looking through the wall of the exposed pipe specimens (with the inner exposed surface facing the bottom of each picture). At 10% of the lifetime a fine degradation layer has formed on the inner exposed surface as seen in Figures 1A and 2A. At 50% of the lifetime, micro-cracks are visible on the inner exposed surface (Figure 1B). The degradation layer thickness has increased (Figure 2B) and the micro-cracks are starting to propagate radially through the pipe wall. At ultimate failure several very large micro-cracks are visible on the inner exposed surface (Figure 1C) and the degradation layer thickness has increased significantly (Figure 2C). Ultimate failure occurred when one of the micro-cracks propagated through the entire wall thickness resulting in a brittle slit failure approximately 2 mm in length.

**Figure 2: Progression of Chlorine Induced Degradation of a PEX Pipe Material: Through the Pipe Wall**

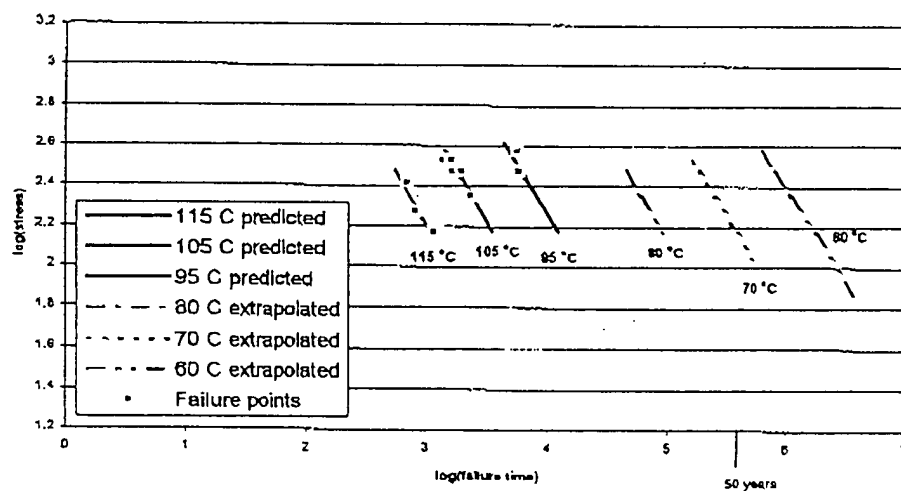
Figure 5 shows a plot of the experimental failure points and the predicted failure times from the Rate Process Model. From the data it is seen that the Rate Process Model provides a good fit to the experimental data. The  $R^2$  for the regression was 0.98. Also shown in Figure 5 are the extrapolated test lifetimes at lower temperatures.

Figure 5: Failure Times for a PEX Pipe Material Exposed to Chlorinated Potable Water.

$$\text{Log (failure time)} = -16.45 + 8367.2/T + 372.2/T * \log (\text{hoop stress}) \quad (2)$$

For domestic plumbing applications the commonly accepted most aggressive end use conditions are 80 psi internal pressure and 60 °C (140 °F) temperature. In actual application both pressure and temperature, or the combination thereof, would be expected to be below these values. Moreover, most domestic plumbing systems do not experience continuous hot water conditions. These conditions would appear, therefore, to be relatively conservative. The extrapolated test lifetime for the PEX material tested based on these conditions is 93 years with a 95% lower confidence limit of 52 years. This estimate is based on testing at aggressive water quality conditions as well as extrapolation to aggressive end use conditions. Even though the presence of the chlorine in the potable water reduces the anticipated performance lifetime of the PEX pipe material tested, the material still appears to have very good chlorine resistance.
